# SCOTT RIVER STREAMBANK PROTECTION TOZIER RANCH

## THE UNITED STATES FISH AND WILDLIFE SERVICE

Project # 14-48-0001-96613

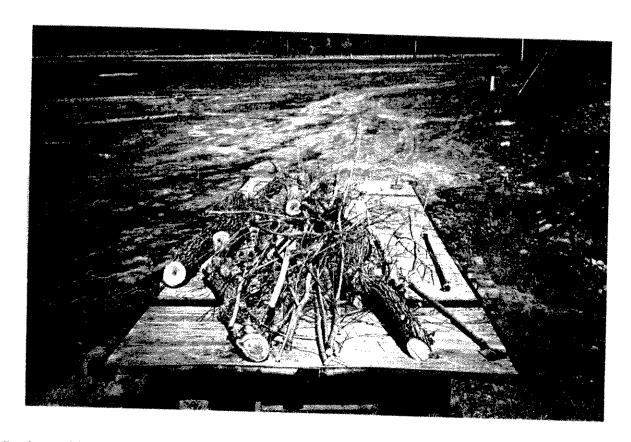
Cuttings which were buried 5 to 7 feet into the ground

<u>-Planting:</u> Two planting methods were installed which the RCD is very confident about. One method used a post hole auger fixed to a back-hoe. The auger could reach depths of up to eight feet below the soil surface. Holes were augured deep into the soil over a 2.3 acre region (.4 acres funded by CDFG). Live willow and cottonwood posts (large diameter material exceeding 10") were collected, placed in the holes, then filled with dirt. Approximately 18" of the stock extends out of the ground while 7-8 feet remains buried where it can reach the water table during low flow periods in the late summer.

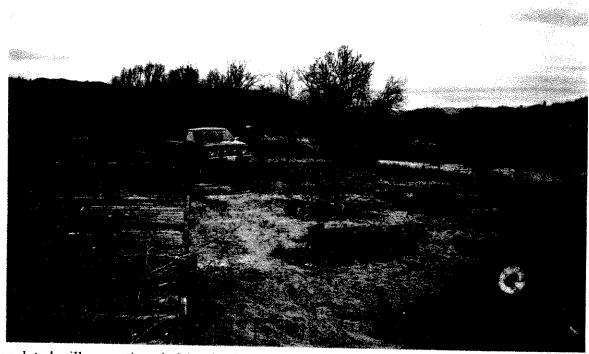
Completed willow cuttings in March of 1997. 100% survival rate as of July 1st 1997

As of July 14th, 1997 nearly all the cuttings were thriving, six trees of over 350 trees had died in the last several weeks due to annual competition and a poor water year. The average growth is roughly 4' since spring with some cuttings exceeding 6'. The RCD is very excited about the possibilities of these planting techniques. Maintenance is minimal and the cost is inexpensive compared to installing and maintaining a drip irrigation system.

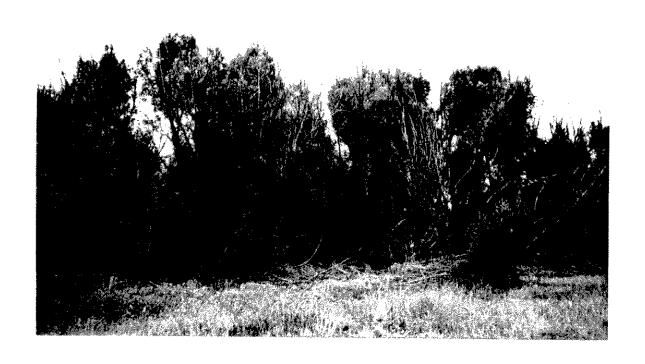
Decadent stands of willow used for planting (cutting) stock
